**Flood Control Project Maintenance
Levee Inspections**

Fall 2013 Levee Maintenance Deficiency Summary Report

Reclamation District No. 2075 McMullin

Levee Inspection Report By Mile - Fall 2013

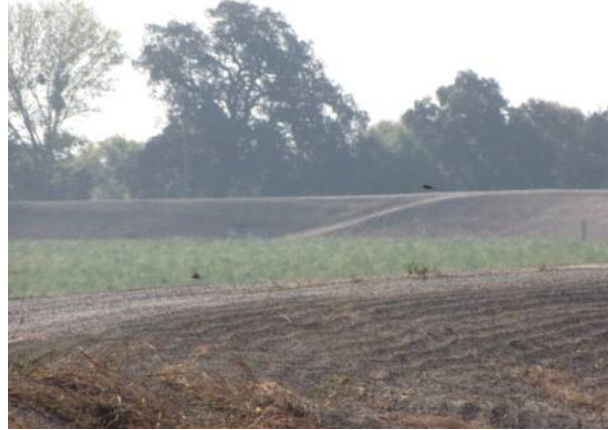
Levee Mile Report Line	4
Start Levee Mile	0.05
End Levee Mile	0.05
Location	Land Side
Category	Earthen Levee
Item	Vegetation

RD 2075 Looking downstream from landside unwanted weeds has been removed from levee section. Photo taken 10-25-2013.

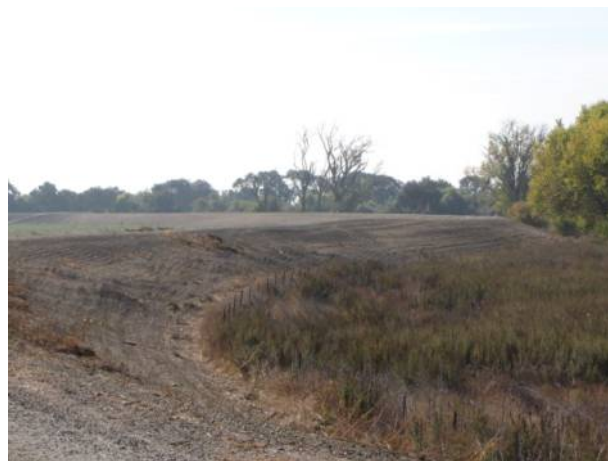
Levee Mile Report Line	5
Start Levee Mile	0.05
End Levee Mile	0.05
Location	Water Side
Category	Earthen Levee
Item	Vegetation

5	0.05	0.05	Earthen Levee	Vegetation	WS A Ma	V2 : Remove the wild growth other than native grasses from the levee slopes. Inspector Comments: Good job on levee slopes.	37.748816 ° -121.289640 °	37.748816 ° -121.289640 °	184 Y
DWR ID: DWR_RD2075_01_s_2012_184									
6	0.09	0.18	Earthen Levee	Vegetation	WS C Ma	V2 : Remove the wild growth other than native grasses from the levee slopes.	37.748629 ° -121.289760 °	37.747389 ° -121.289424 °	15
DWR ID: DWR_RD2075_01_f_2012_15									
7	0.75	0.75	Earthen Levee	Encroachments	WS M En	TA : Tank Inspector Comments: The land owner has a fuel tank on a metal platform waterward levee section. This is all part of a raised pad build here before the home was built.	37.742025 ° -121.284827 °	37.742025 ° -121.284827 °	13
DWR ID: DWR_RD2075_01_s_2012_13									
8	0.85	1.39	Earthen Levee	Vegetation	WS C Ma	V2 : Remove the wild growth other than native grasses from the levee slopes.	37.741576 ° -121.283021 °	37.735311 ° -121.283118 °	20

RD 2075 Looking downstream from waterside District has removed all brush and weeds from levee section. Photo taken 10-25-2013.

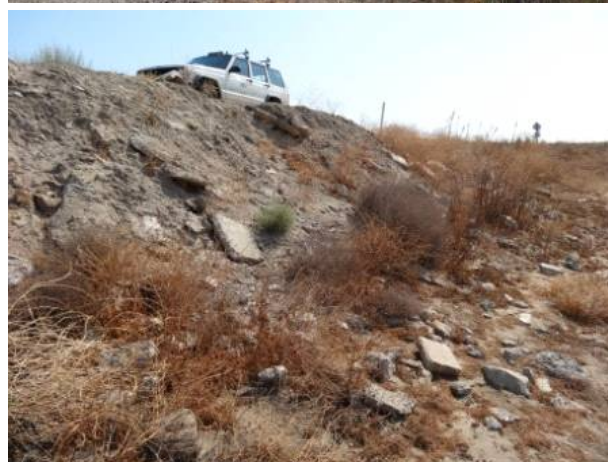
Levee Mile Report Line	10
Start Levee Mile	5.34
End Levee Mile	5.35
Location	Water Side
Category	Supplemental
Item	DWR Erosion Survey

LMR No.	Levee Mile		Category	Item	Location	Rating	Action/Comment	GPS Latitude/Longitude		Issue No. Photo
	Start	End						Start	End	
10	5.34	5.35	Supplemental	DWR Erosion Survey	WS	M Ma	Inspector Comments: 09/10/2013: No significant change observed. 09/13/2012: No significant change observed. 08/18/2011: No significant change observed. Some new material added to the water side levee slope, but the added material is loose and seems not helping the levee protection. 10/05/2010: No significant changes observed. Levee slope has minimal vegetation and lacks rip rap protection. Sandy material found on the lower and middle slope is an undesirable material to have on a levee. 08/05/2010: Recommended for annual assessment and monitoring during flood events, per CLRO. 08/20/2009: No major change since last visit; site is located in an oxbow; slope surface consists of very sandy material; there is a tree on site leaning and with exposed tree roots; site is recommended as a local maintenance issue, per CLRO CES Evaluation 2008 Report; Eddy Cordoza from the district is aware of the site and is looking for recommendation; site is previously rated "U". 08/17/2007: Site is close to an irrigation pump inlet. [2013 Site ID:RD2075U01RM64.34]	37.727933 ° -121.274491 °	37.727933 ° -121.274491 °	1 Y

Looking up to the levee crown at the added material.
